APGC-TDR-62-57

Structural Compatibility Test of M61 Gun/Linkless Feed Subsystem and F-105D Aircraft

APGC Technical Documentary Report No. APGC-TDR-62-57

OCTOBER 1962 • APGC Project No. 306A716

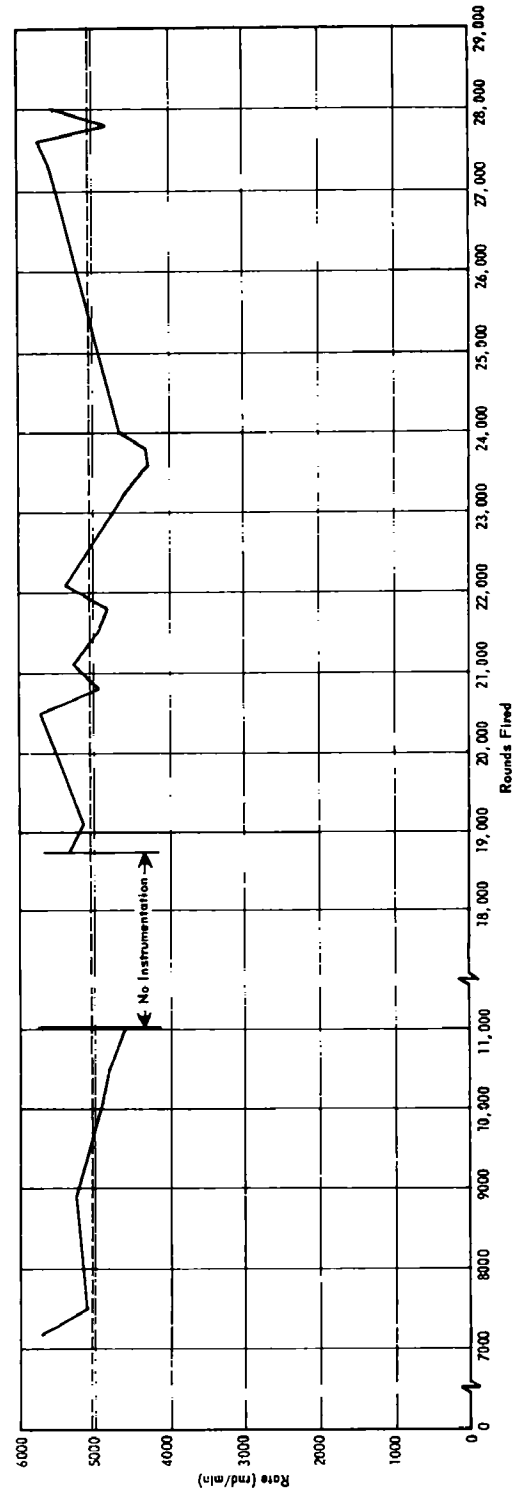
The average firing rate of the M61 gun/linkless feed subsystem, as installed in the F-105D aircraft, was found to be 5038 rounds/min (Fig. 5 and Appendix III).

Fig. 5: Firing Rate for M61 Gun/Linkless Feed Subsystem (as installed in F-105D aircraft).
